1. REPORT NO. CA-TL-79-01		2. GOVERNMENT ACCESSION NO.		3. RECIPIENT'S CATALOG NO.	
4. TITLE AND SUBTITLE VEHICULAR IMPACT TEST ON STEEL CHANNEL-BEAMS SPANNING A GAP IN A CONTINUOUS CONCRETE MEDIAN BARRIER				5. REPORT DATE February 1979

STATE OF CALIFORNIA
DEPARTMENT OF TRANSPORTATION
DIVISION OF CONSTRUCTION
OFFICE OF TRANSPORTATION LABORATORY

VEHICULAR IMPACT TEST ON STEEL
CHANNEL BEAMS SPANNING A GAP IN A
CONTINUOUS CONCRETE MEDIAN BARRIER

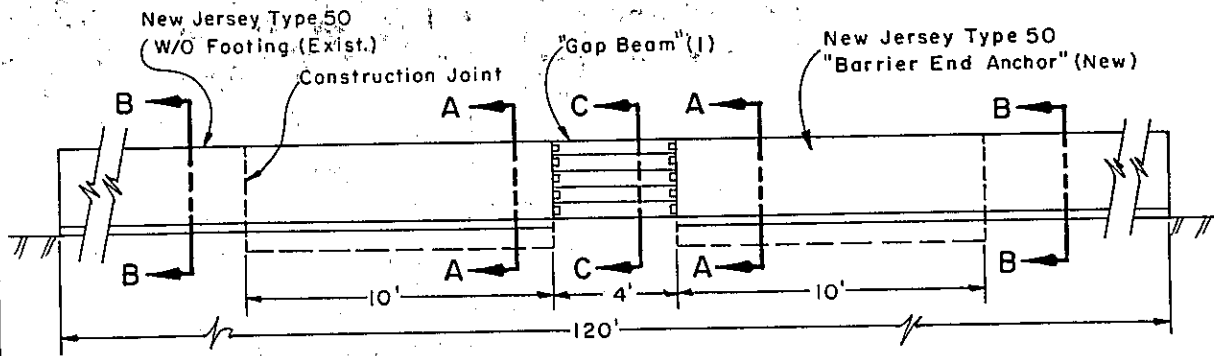
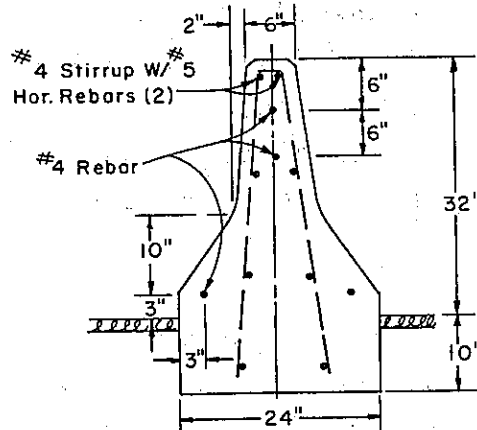
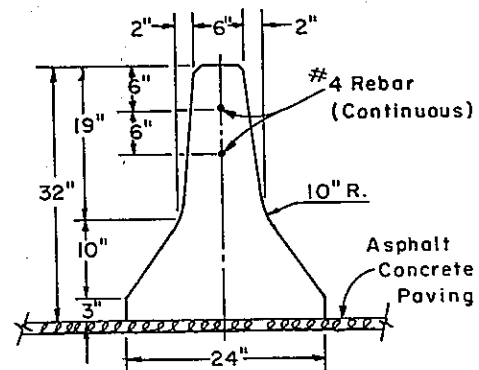
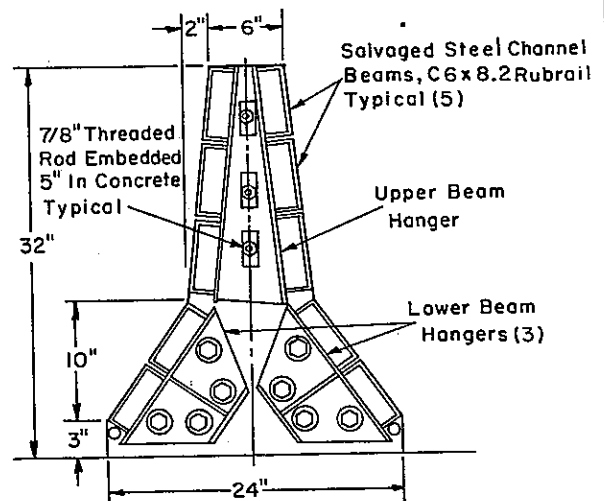
Figure 2, GAP BEAM SUMMARY SHEET *

The remaining 4 foot gap was spanned with an assemblage of steel hangers and beams, the "gap beam design". Figures 2 and 3 show the main elements of that design. Complete details of the gap beam design are shown in the Appendix, Figure 10A.

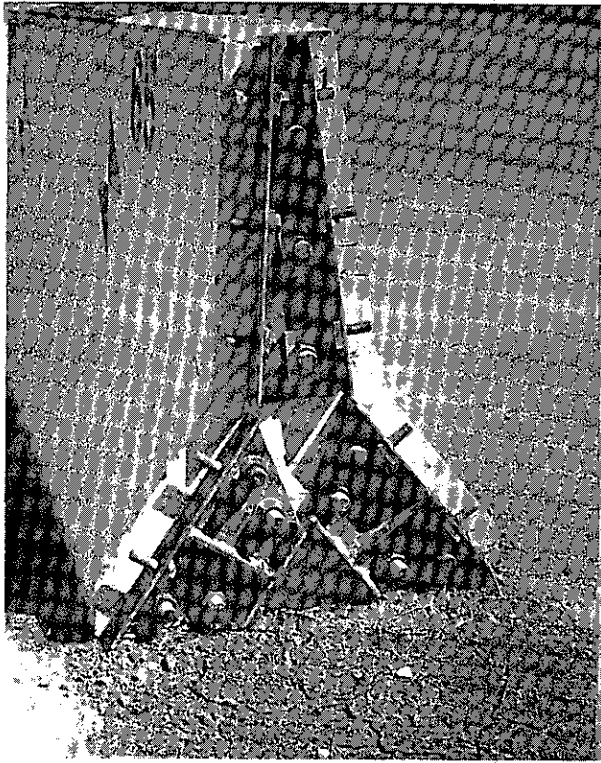
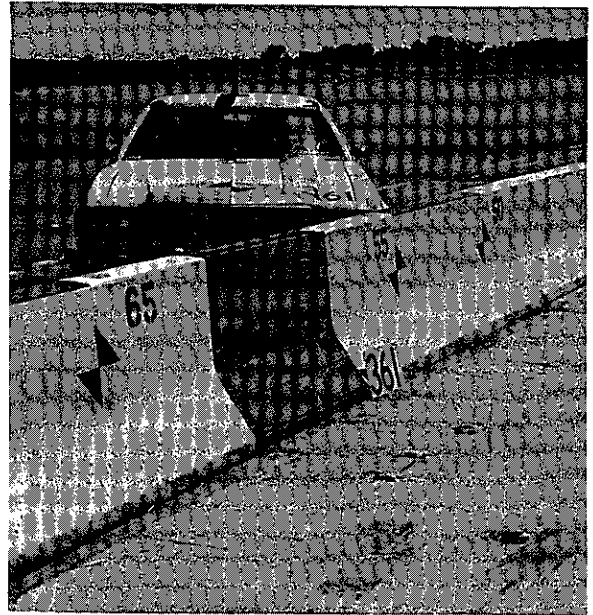
Figure 3 - Main Elements of Gap Beam Design

Threaded rods $7/8$ inch in diameter, were cast in place in the ends of the new sections of CMB. They were embedded 5 inches in the concrete. The upper and lower beam hanger brackets, which were cut from pieces of C6x8.2 steel channel rubrail, were then bolted on and adjusted, making sure the beams would be flush with the outside face of the barrier. The nuts were torqued to 150 ft-lbs. Finally the channel beams, C6x8.2, were bolted on to the hanger brackets. The nuts were torqued
